FINAL SITE INSPECTION REPORT

TEST AREA 7 (T-7)

LOUISIANA ARMY NATIONAL GUARD
CAMP MINDEN, LOUISIANA

JUNE 2014

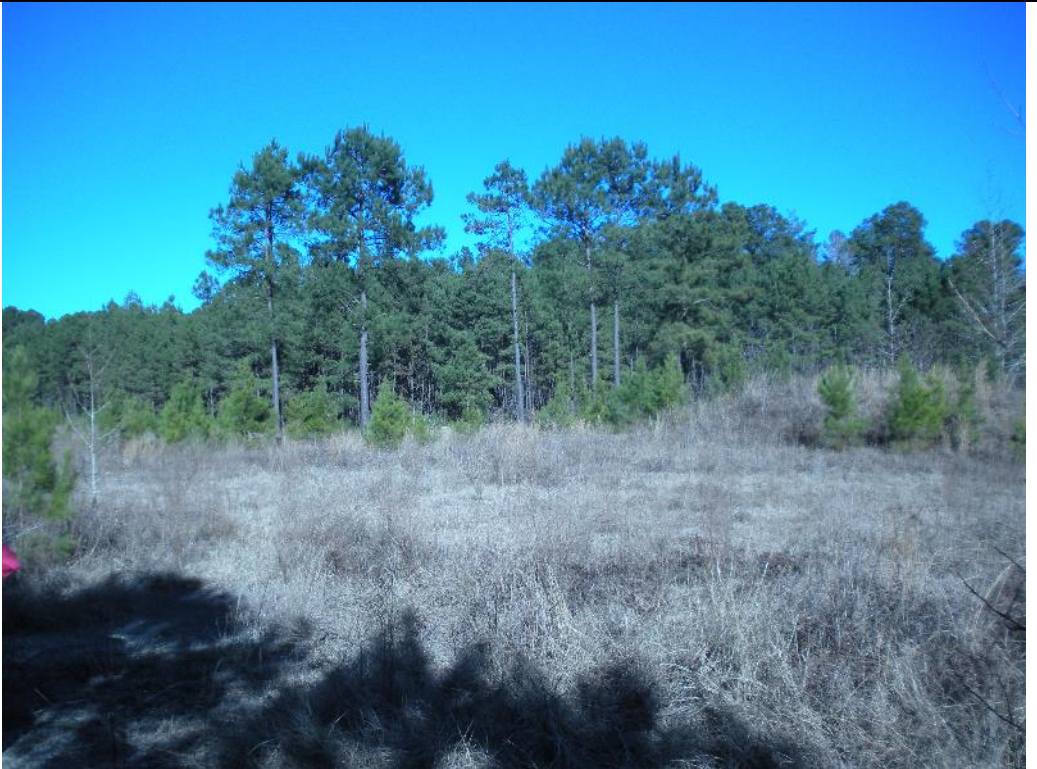
Client Name: USACE – Fort Worth District		Site Location: Camp Minden Army National Guard, Louisiana	Project No. 1293
Photo No. 1	Date: 1/16/14

Direction Photo Taken: Northeast			
Description: View of heavily wooded area in the west central section of Test Area 7 (T-7).

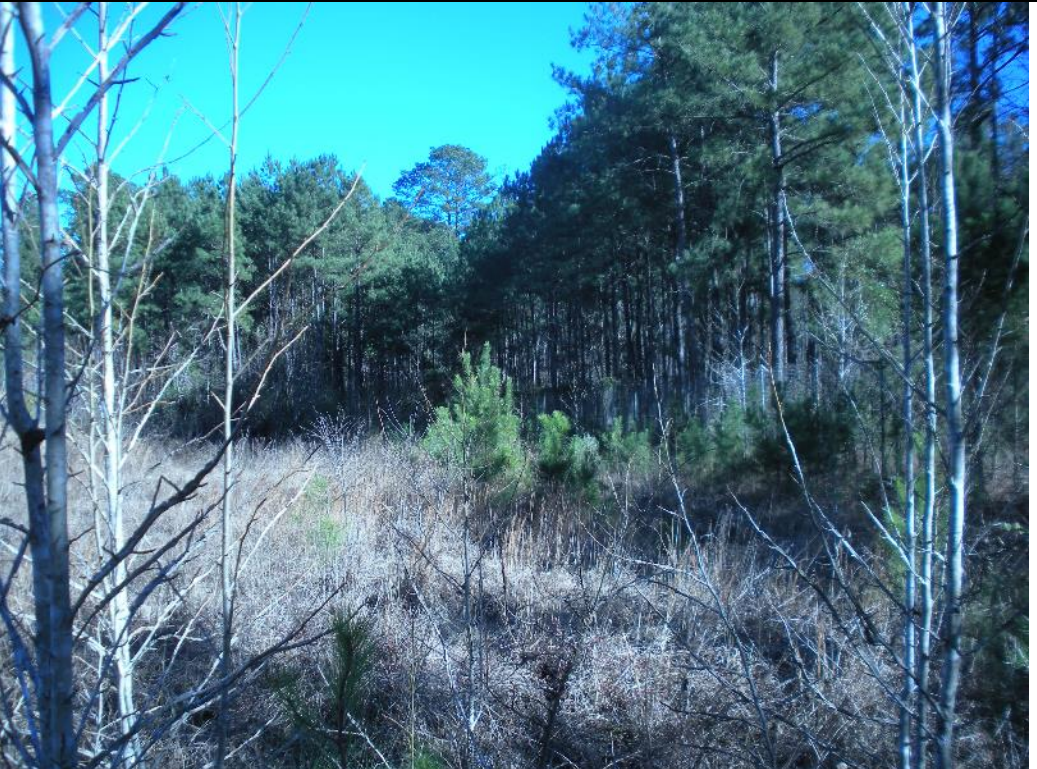
Photo No. 2	Date: 1/16/14

Direction Photo Taken: North		
Description: View of the tree lined eastern fence line of the T-7 Area.

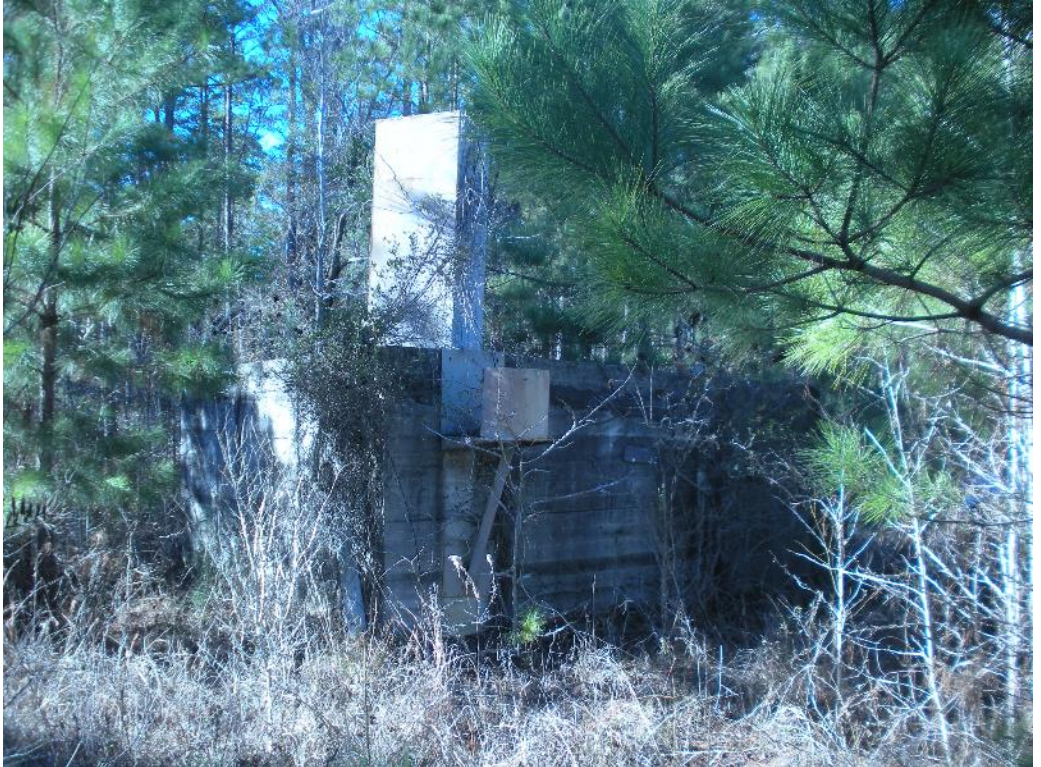
Client Name: USACE – Fort Worth District		Site Location: Camp Minden Army National Guard, Louisiana	Project No. 1293
Photo No. 3	Date: 1/16/14

Direction Photo Taken: Southwest			
Description: View of intact bunker located in the southwestern corner of the T-7 Area.

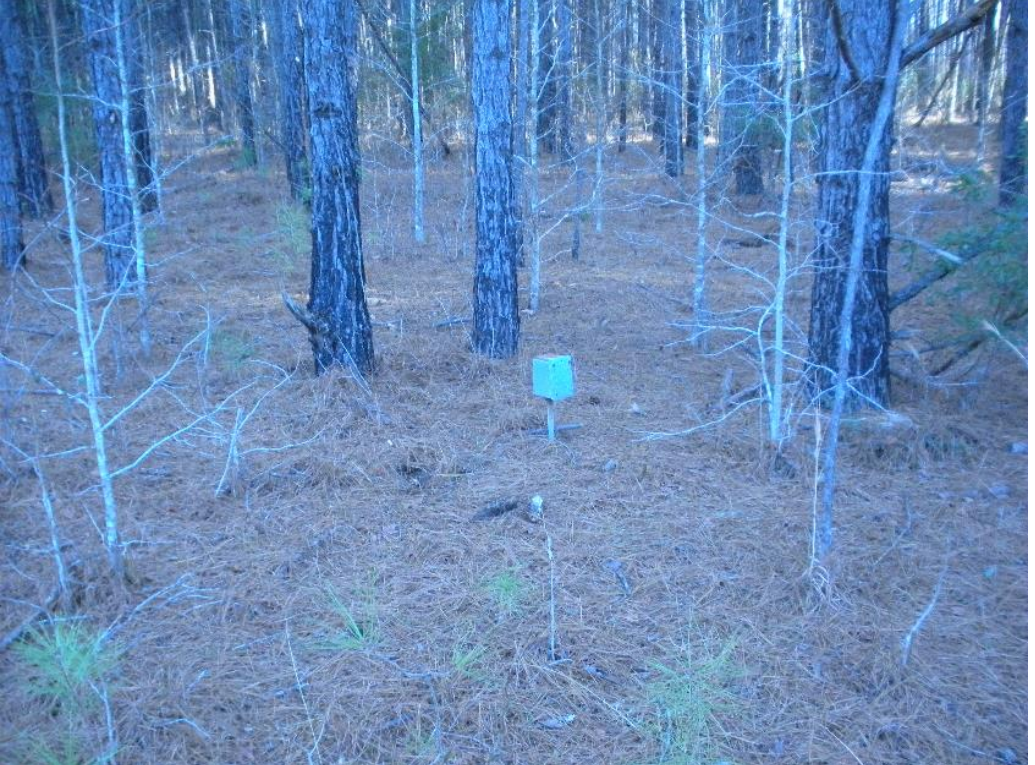
Client Name: USACE – Fort Worth District		Site Location: Camp Minden Army National Guard, Louisiana	Project No. 1293
Photo No. 7	Date: 1/16/14

Direction Photo Taken: East			
Description: View of an electric junction box with conduit leading into the ground. There were multiple locations of linear metallic anomalies which could be attributed to the buried conduit.

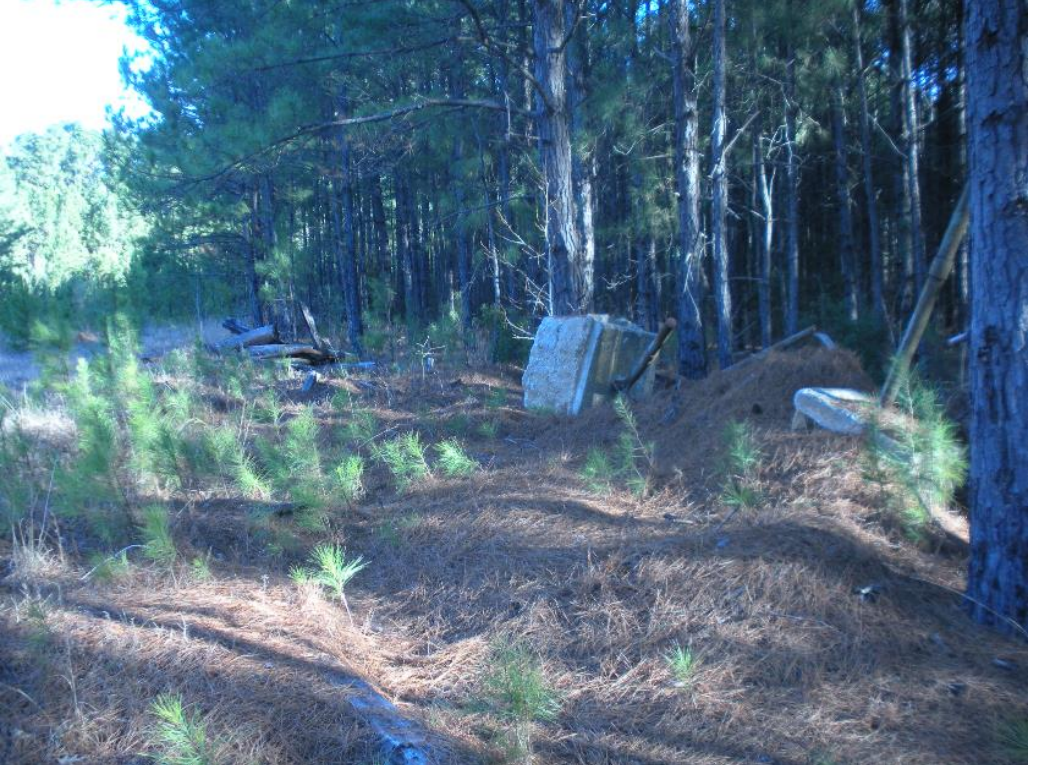
Client Name: USACE – Fort Worth District		Site Location: Camp Minden Army National Guard, Louisiana	Project No. 1293
Photo No. 9	Date: 1/16/14

Direction Photo Taken: North			
Description: View of concrete and metal debris field along transect 10.

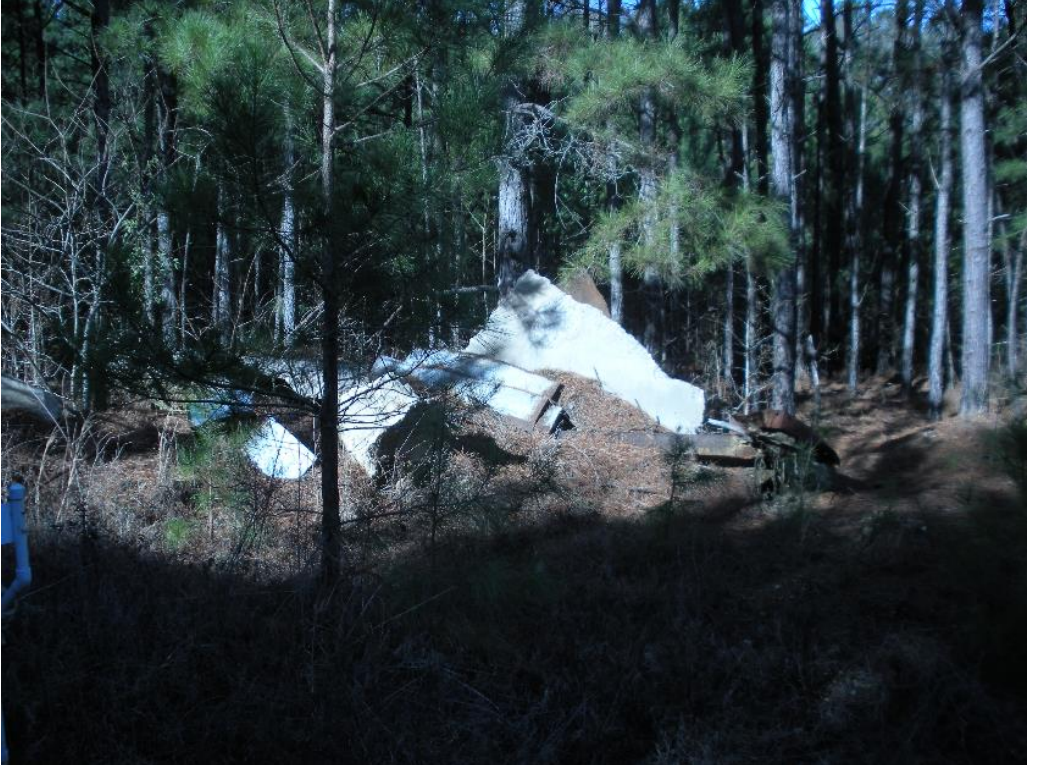
Client Name: USACE – Fort Worth District		Site Location: Camp Minden Army National Guard, Louisiana	Project No. 1293
Photo No. 11	Date: 1/16/14

Direction Photo Taken: West			
Description: View of concrete and metal debris pile located along transect 14.

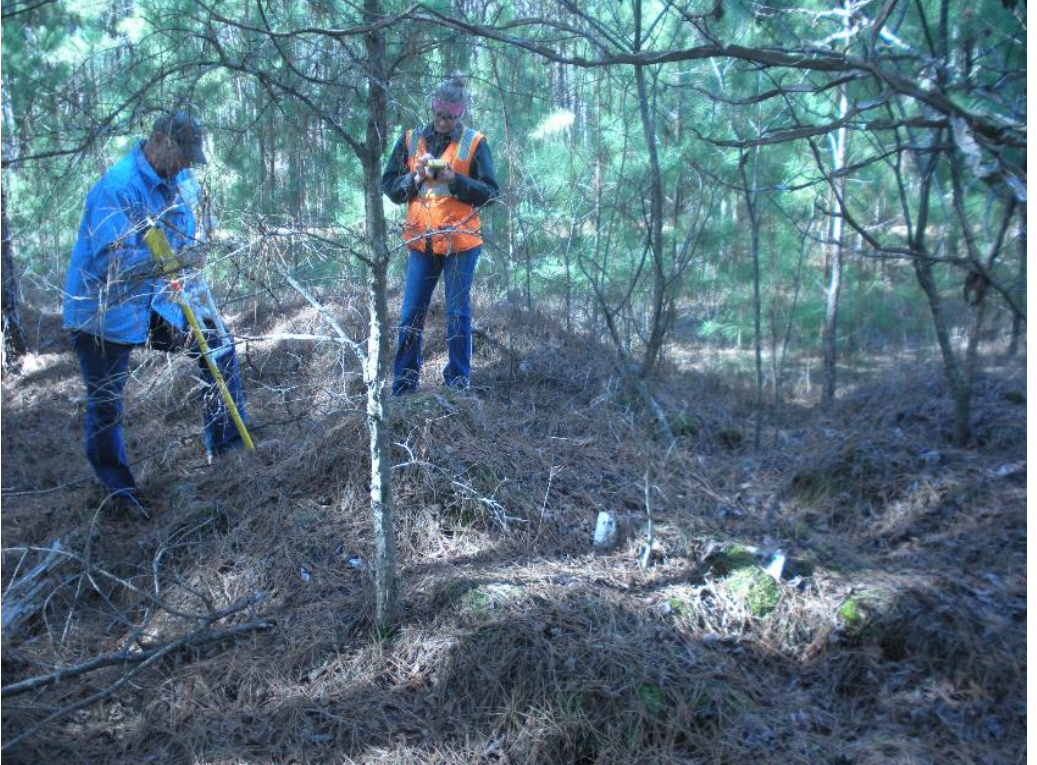
Client Name: USACE – Fort Worth District		Site Location: Camp Minden Army National Guard, Louisiana	Project No. 1293
Photo No. 13	Date: 1/16/14

Direction Photo Taken: North			
Description: View of field survey crew collecting the data point of a metallic anomaly.

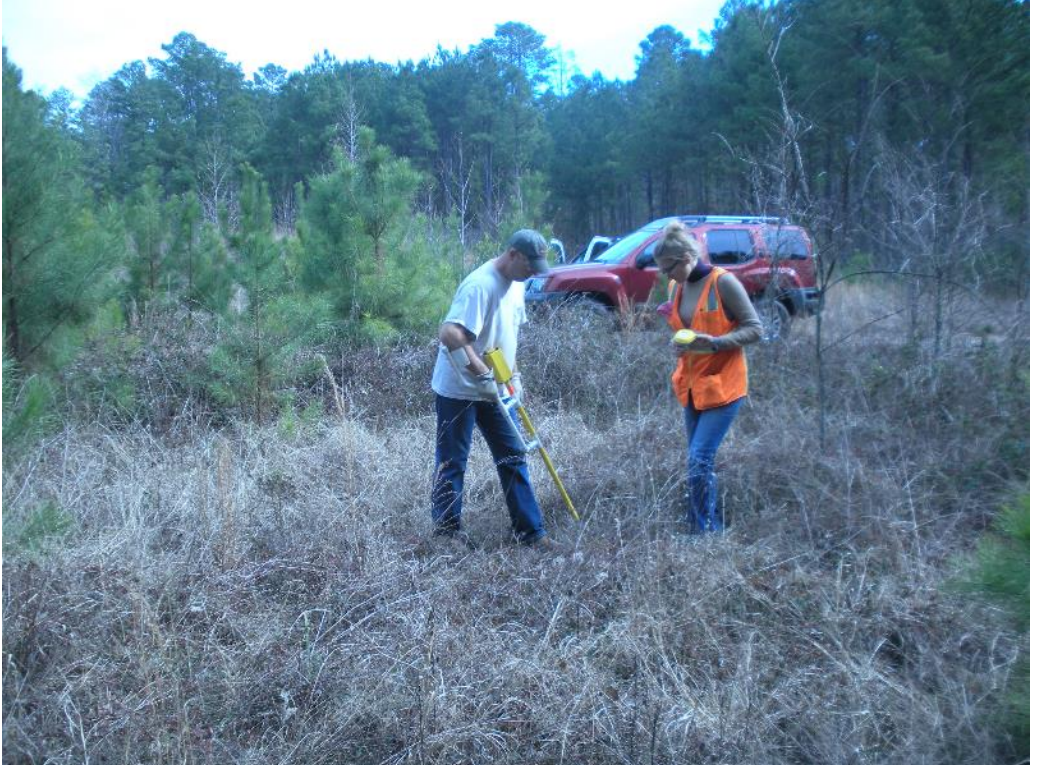
Client Name: USACE – Fort Worth District		Site Location: Camp Minden Army National Guard, Louisiana	Project No. 1293
Photo No. 15	Date: 1/16/14

Direction Photo Taken: East			
Description: View of field survey crew collecting the data point of a metallic anomaly. The field vehicles are parked on the gravel road in the background.
